# INSPECTION REPORT

For the Property at:  
**12345 NEWHOME AVE S**  
SEATTLE, WA 98101

Prepared for: JOHN DOE  
Inspection Date: Friday, July 24, 2020  
Prepared by: Luke Chmura, WA DOL #2548

Puget Home Inspection  
14844 5TH AVE S  
Burien, WA 98168  
(206)333-7388

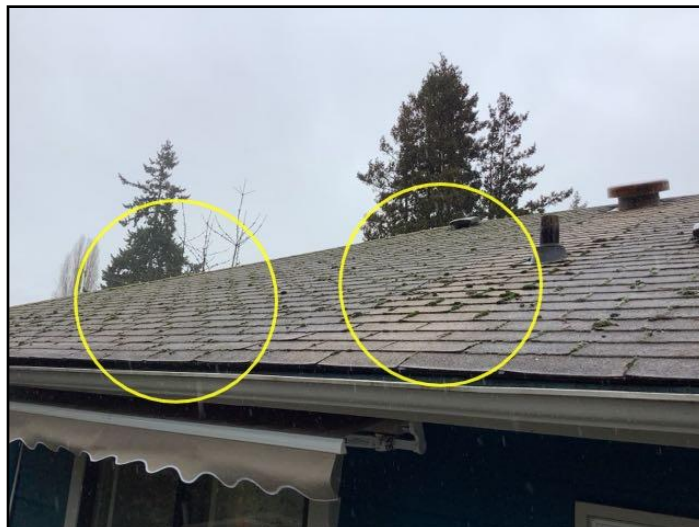
**1. Condition:** • Debris/moss/algae

The asphalt shingle roof had areas of moss growth. This condition indicates high moisture levels. Moss growth may increase the chances of roof leakage by slowing drainage or reduce the wind resistance of the shingles through root tendril invasion of sealant strips. Moss is easily removed using a soft-bristle brush. I recommend removal by a qualified roofing contractor.

1. Debris/moss/algae

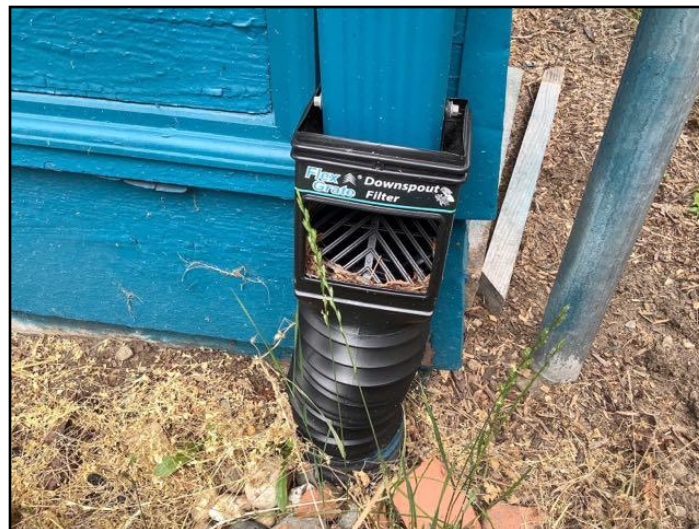
#### 2. Condition: • [Discharge below grade](#)

Downspout discharging into below grade flexible pipe. This type of ribbed pipe is prone to clogging

6. Discharge below grade

**Task:** Improve

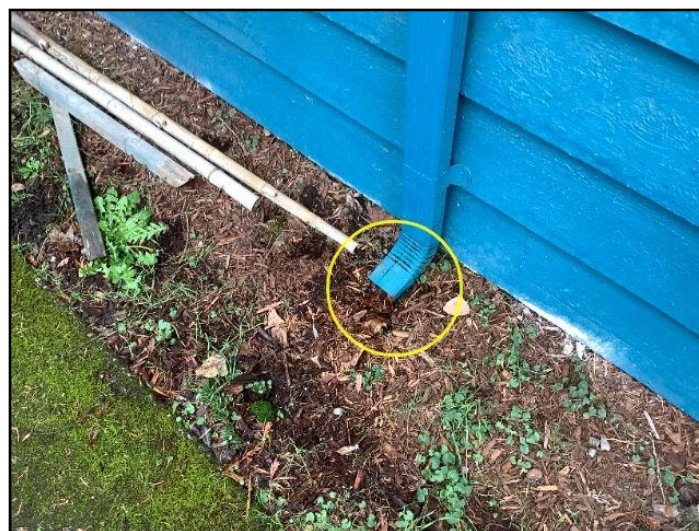
#### 3. Condition: • Discharge too close to building

One or more downspouts discharged roof drainage next to the foundation. The home had downspouts missing. This condition can result in excessively high moisture levels in soil at the foundation and can cause damage related to soil/foundation movement. Excessive moisture levels in soil near the foundation can affect the ability of the soil to support the weight of the structure above and can cause damage related to soil/foundation movement. I recommend the

7. Discharge too close to building

installation of downspout extensions to discharge roof drainage a minimum of 6 feet from the foundation.

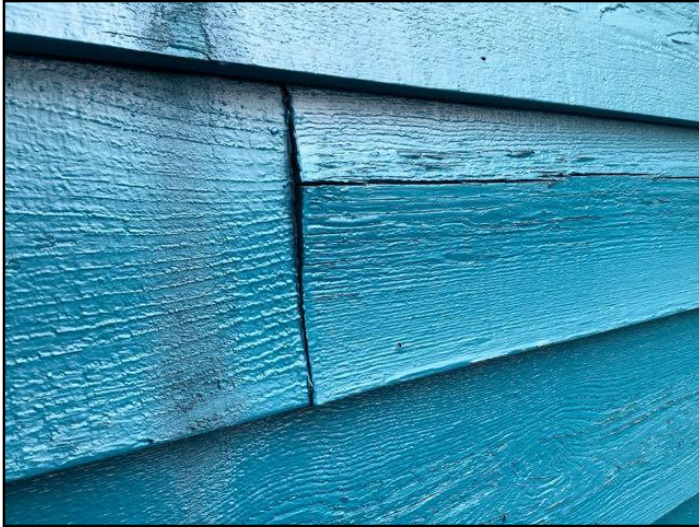
4. Condition: • [Cracked, split or broken](#)

Siding is loose on several locations on south side of house

8. Cracked, split or broken

**Task:** Repair or replace by qualified contractor

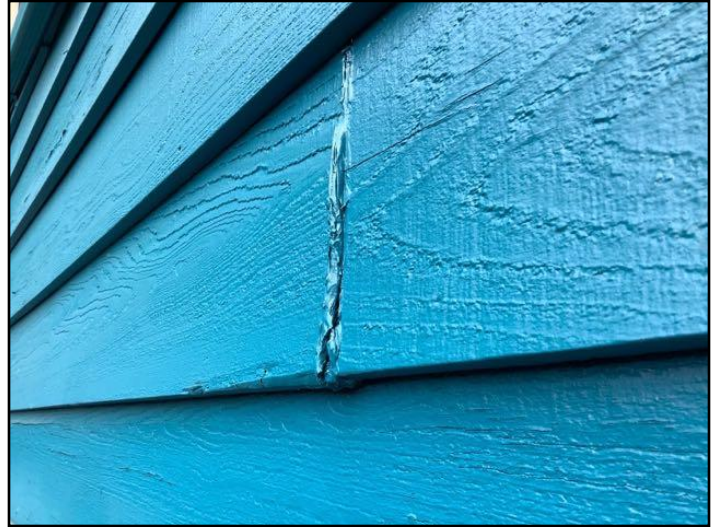
9. Cracked, split or broken

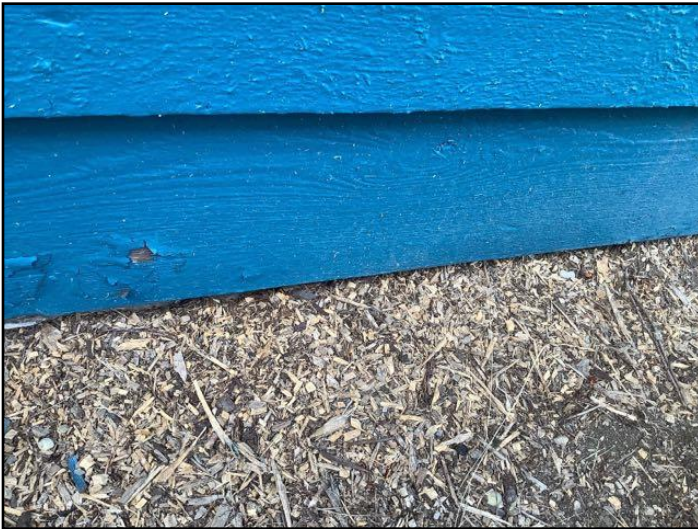
5. **Condition:** • [Too close to grade](#)

Siding should be 6 inches above grade with grades slipping away from house

10. Too close to grade

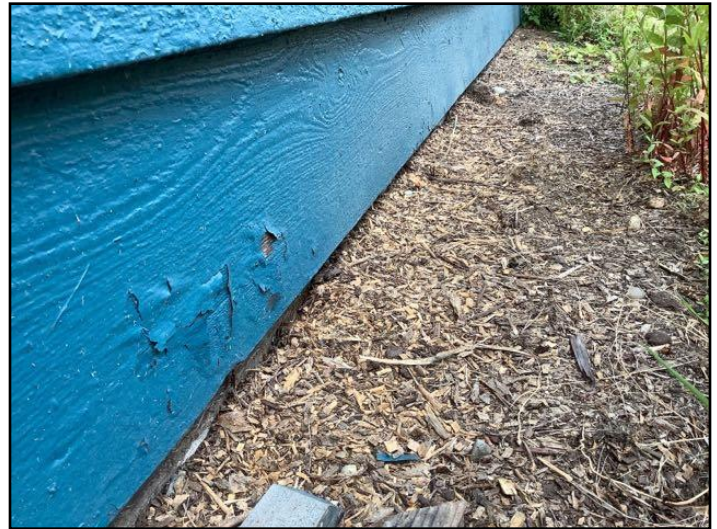
11. Too close to grade

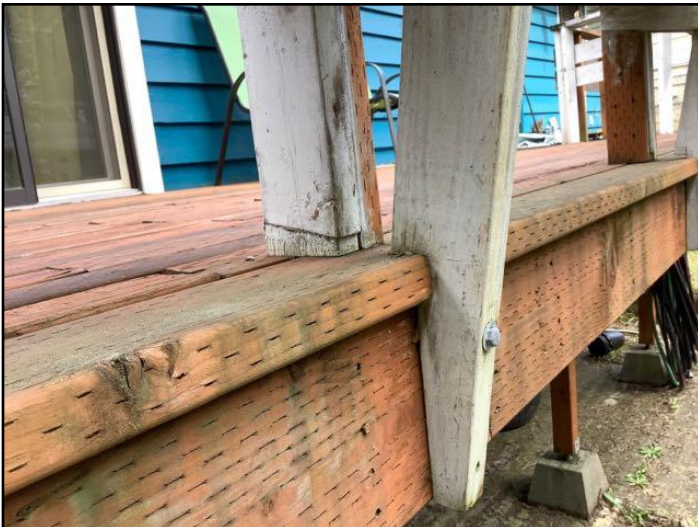
**6. Condition:** • Poorly built

Deck is unprofessionally built. Appears to be structurally unsound in seating area

12. Poorly built

**Task:** Call qualified contractor or carpenter to evaluate and repair where needed

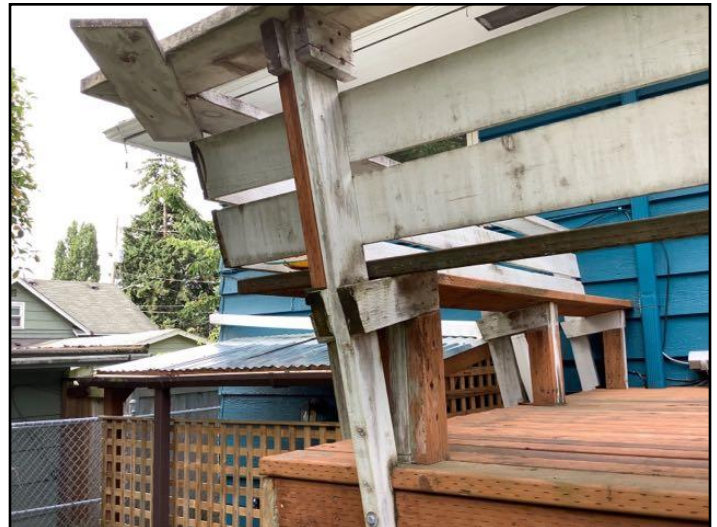
13. Poorly built

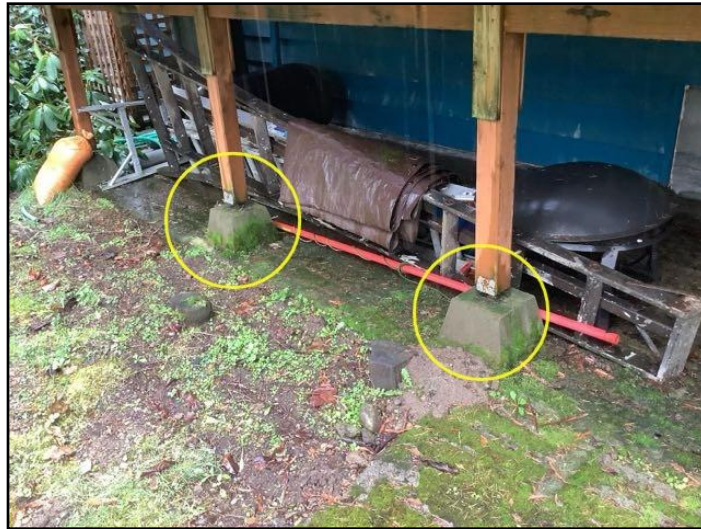
**7. Condition:** • Portable concrete piers

The deck structure rested upon portable concrete piers. This type of footing is not recommended by the DCA 6, a widely regarded deck standard. Consider upgrading these with in-ground concrete footings.

14. Portable concrete piers

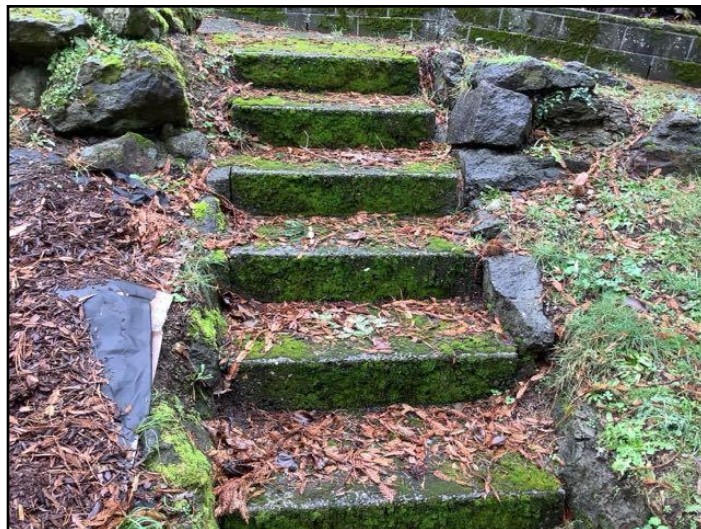
**8. Condition:** • Missing handrail / guardrail

The walkway stairs had no handrail. Safe building practices dictate that stairs with four or more risers should have a handrail. I recommend installation of a handrail meeting modern safety standards by a qualified contractor.

15. Missing handrail / guardrail

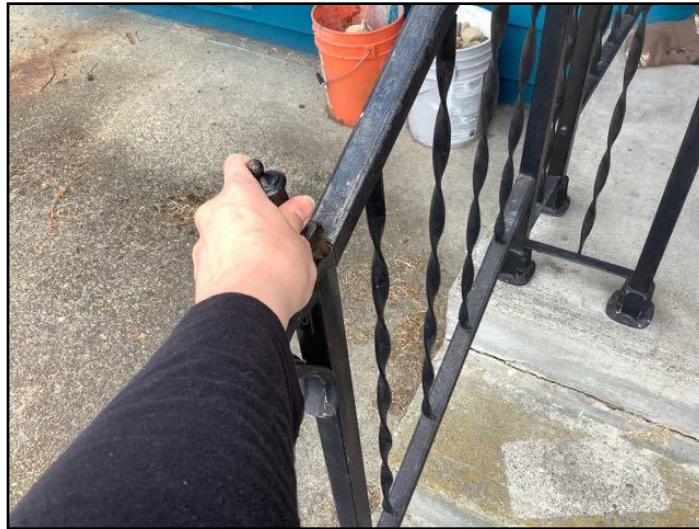
**9. Condition:** • Loose guardrail assembly

16. Loose

**Task:** Repair

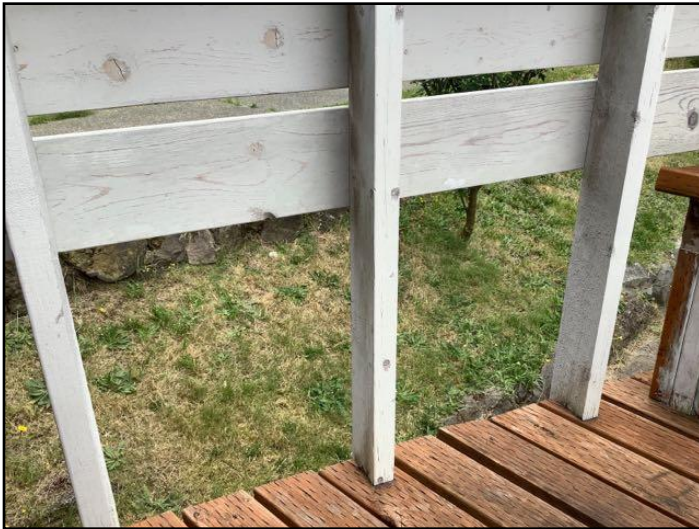
**10. Condition:** • [Openings between spindles \(balusters\) too large](#)

17. Openings too large

**Task:** Correct

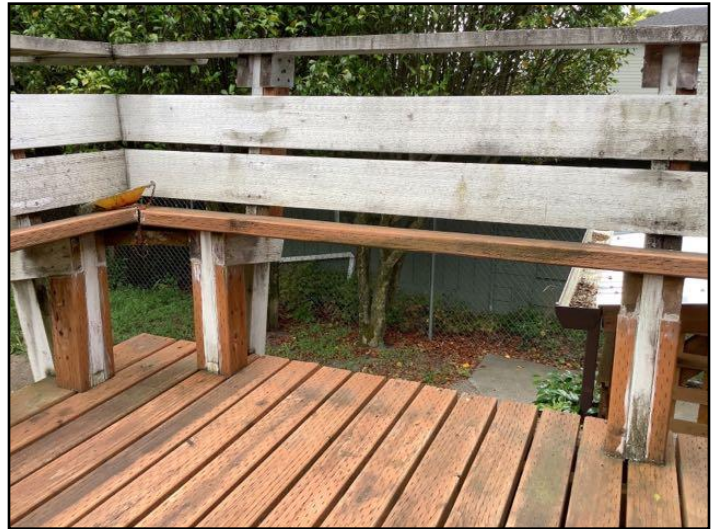
18. Openings too large

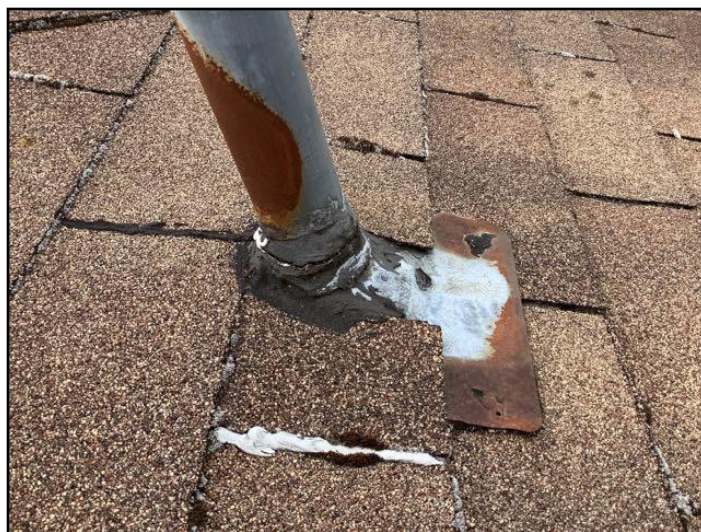
**SERVICE DROP AND SERVICE ENTRANCE \ Service mast and conductors****12. Condition:** • [Mast not weather-tight](#)

The masthead flashing boot is old and worn out. This is a possible entry point for moisture.

**26.** Mast not weather-tight

**Task:** Improve

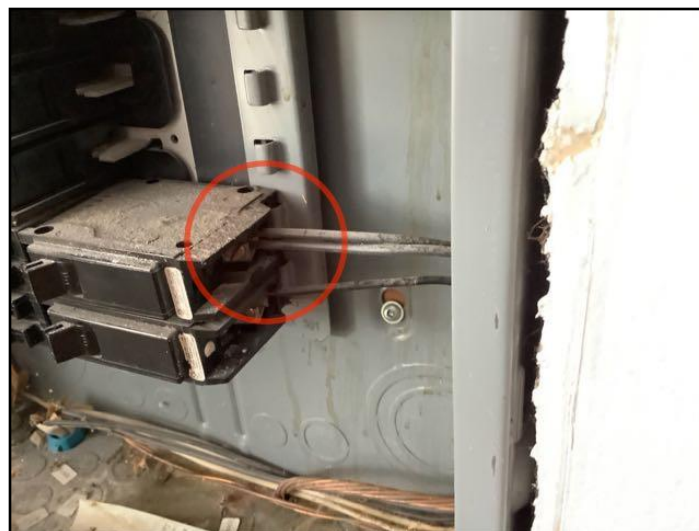
**DISTRIBUTION SYSTEM \ Wiring (wires) - installation****13. Condition:** • [Double taps](#)

In the service panel, multiple neutral conductors terminated under one screw at a breaker. This condition is dangerous because it complicates the isolation of individual circuits. I recommend correction by a qualified electrical contractor.

27. Double taps

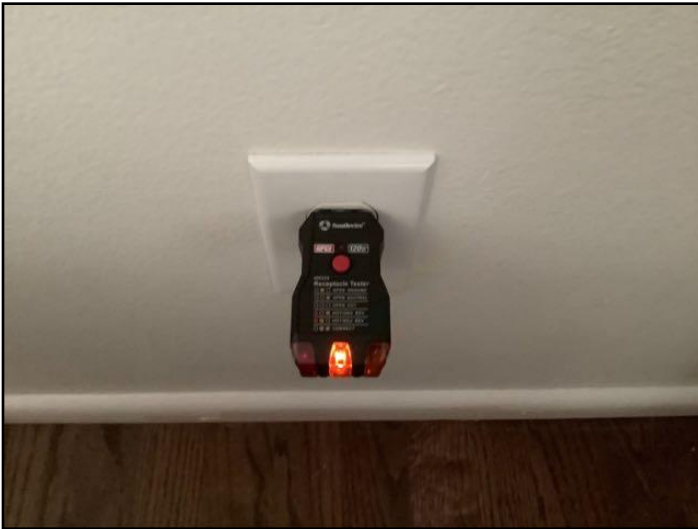
**DISTRIBUTION SYSTEM \ Outlets (receptacles)****14. Condition:** • Ungrounded receptacle reading

Branch wiring was ungrounded. For safety reasons, I recommend that receptacles located in basements, crawlspaces, garages, the home exterior, and interior receptacles located within 6 feet of a plumbing fixture be provided with ground fault circuit interrupter (GFCI) protection in good working order to help avoid potential electric shock or electrocution hazards. This can be achieved relatively inexpensively by:

28. Ungrounded

**Task:** Recommended qualified electrician to improve with grounded wires

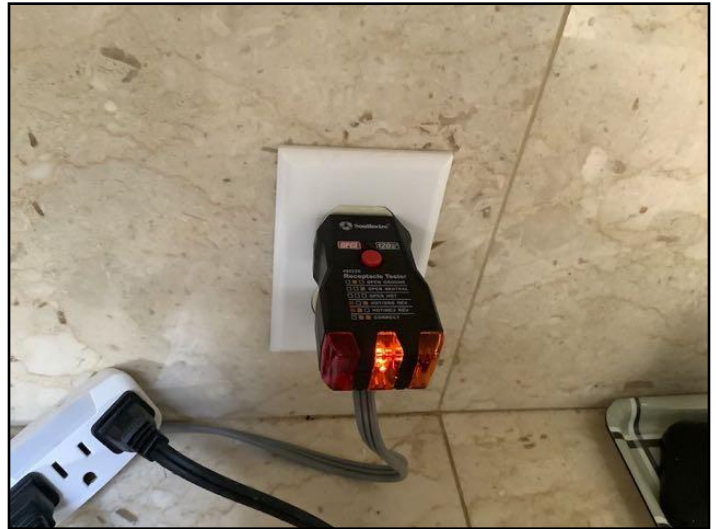
29. Ungrounded

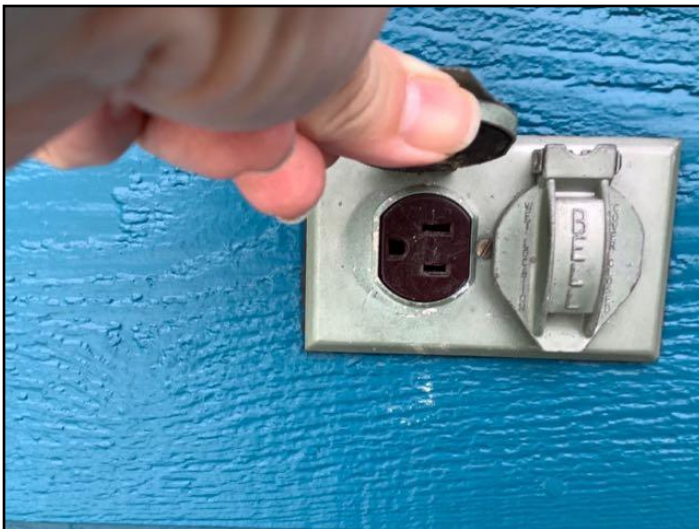
**15. Condition:** • No GFCI

Although GFCI protection may not have been required at the time the home was built, for safety reasons, I recommend that electrical receptacles located in basements, crawlspaces, garages, the home exterior, and interior receptacles located within 6 feet of a plumbing fixture be provided with ground fault circuit interrupter (GFCI) protection in good working order to avoid potential electric shock or electrocution hazards. This can be achieved relatively inexpensively by:

30. GFCI/GFI needed (Ground Fault Circuit...

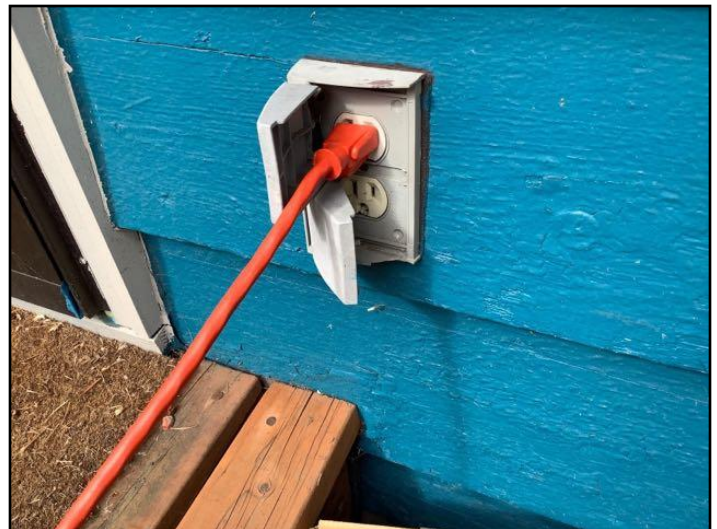
31. GFCI/GFI needed (Ground Fault Circuit...

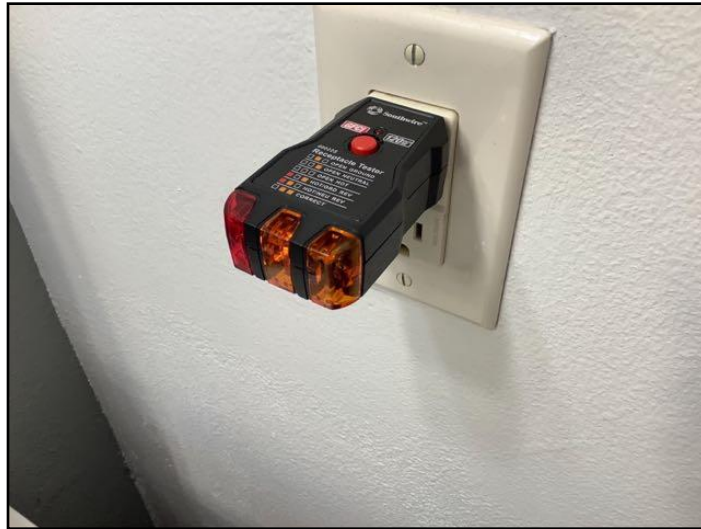
32. Ungrounded GFCI in Bathroom

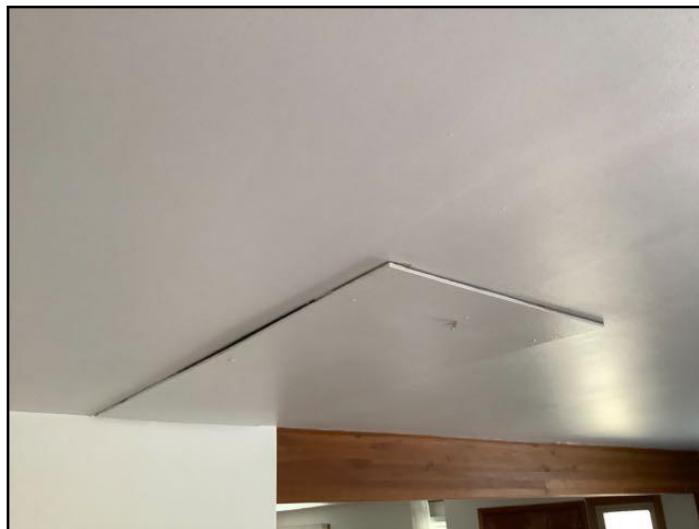
**19. Condition:** • [Inadequate insulation](#)

42. Inadequate insulation

**Task:** Improve

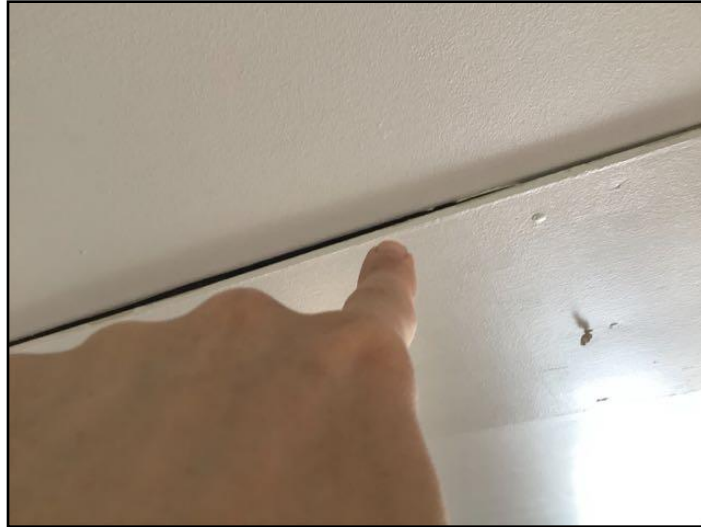
**20. Condition:** • [Inadequate weatherstripping](#)

**Implication(s):** Chance of condensation damage to finishes and/or structure | Increased heating and cooling costs | Reduced comfort

**43.** *Inadequate weatherstripping*

**Task:** Improve

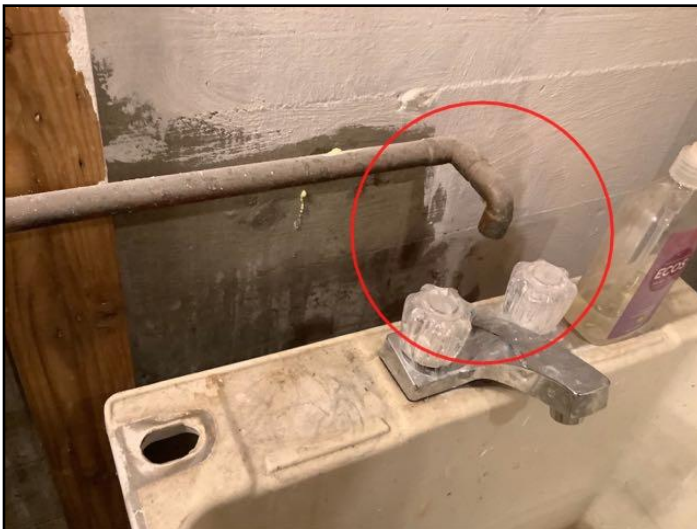
**22. Condition:** • Discharge arrangement poor

50. Discharge arrangement poor

**Task:** Improve

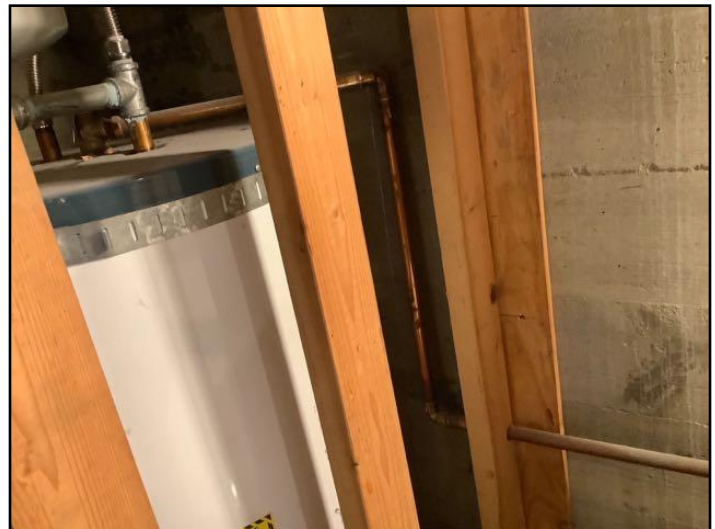
51. Discharge arrangement poor

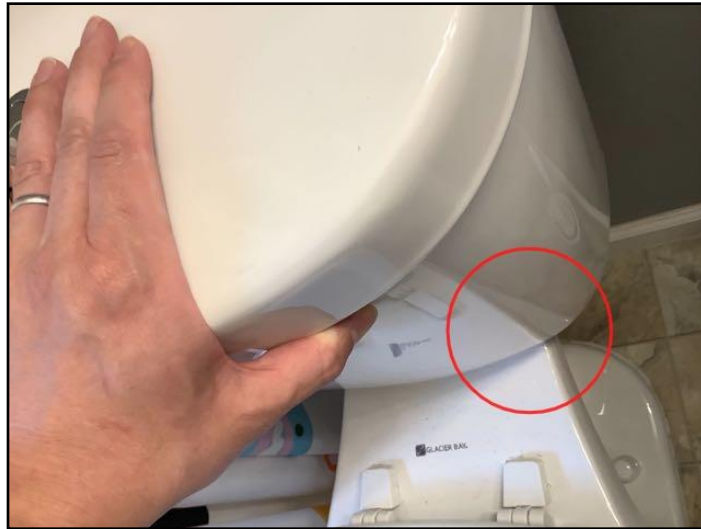
### 23. Condition: • [Loose](#)

In this bathroom, the toilet was loose at the tank and should be securely attached by a qualified plumbing contractor.

52. Loose

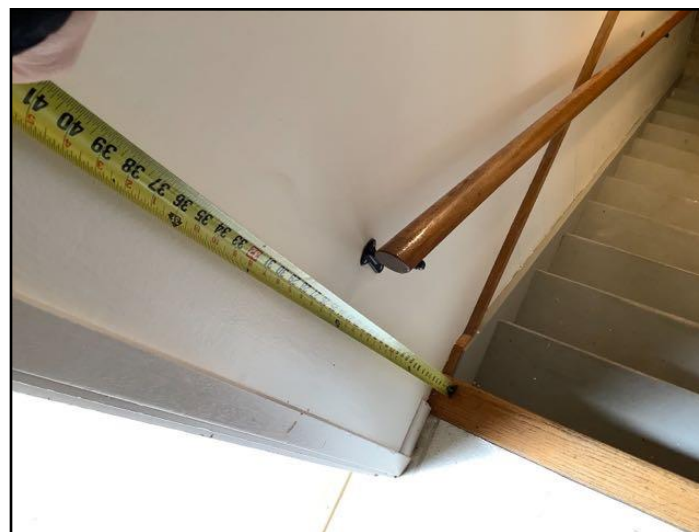
**25. Condition:** • [Too low](#)

60. Too low

**Task:** Correct

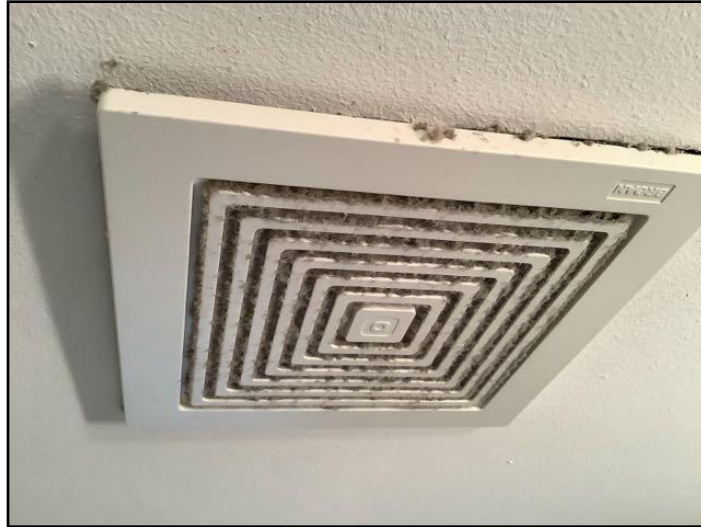
**27. Condition:** • Dirty

**Implication(s):** Poor airflow, increased moisture

61. *Dirty*

**Task:** Clean up, Level 2 - Moderate
