# INSPECTION REPORT

For the Property at:  
**12345 NEWHOME AVE S**  
SEATTLE, WA 98101

Prepared for: JOHN DOE  
Inspection Date: Friday, July 24, 2020  
Prepared by: Luke Chmura, WA DOL #2548

Puget Home Inspection  
14844 5TH AVE S  
Burien, WA 98168  
(206)333-7388

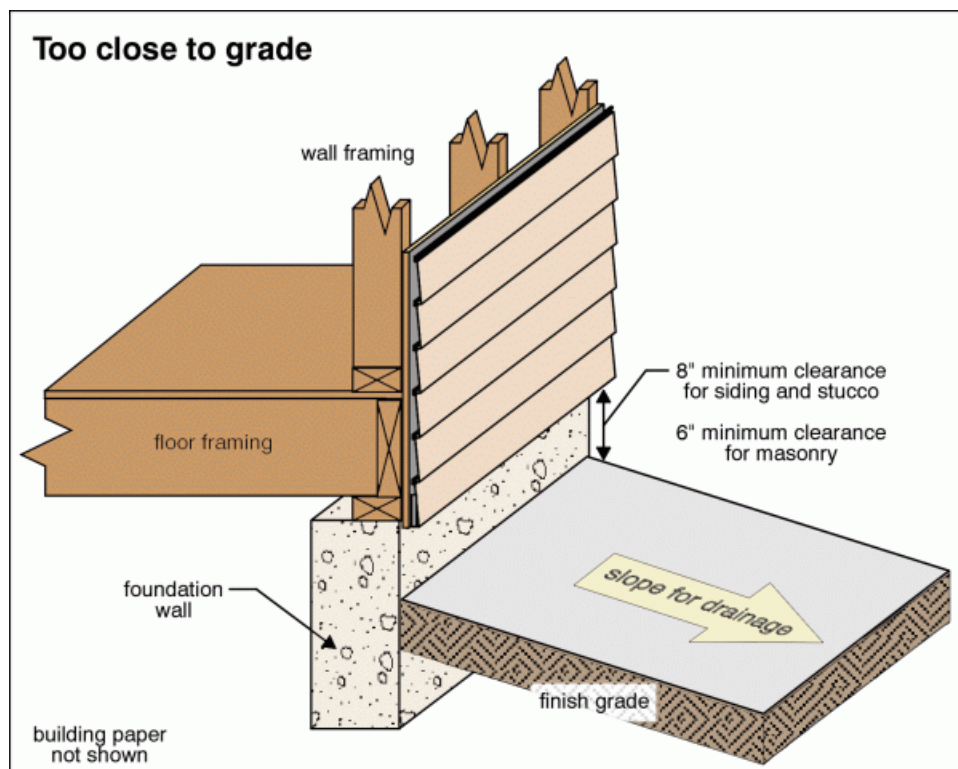
5. **Condition:** • [Too close to grade](#)

**Implication(s):** Chance of water damage to structure, finishes and contents | Material deterioration | Rot | Insect damage

**Location:** exterior north

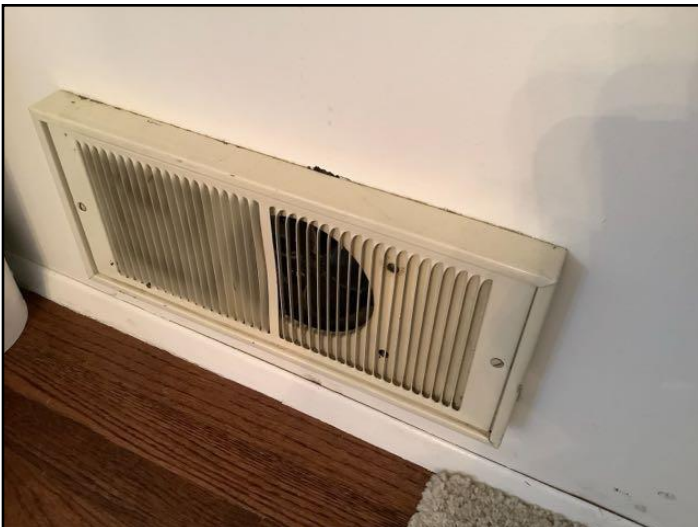
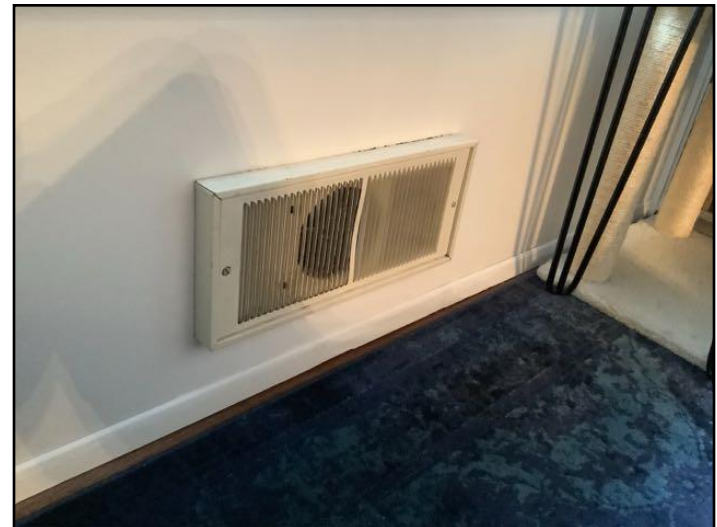
The space heaters in the living room were tested and working at the time of inspection.

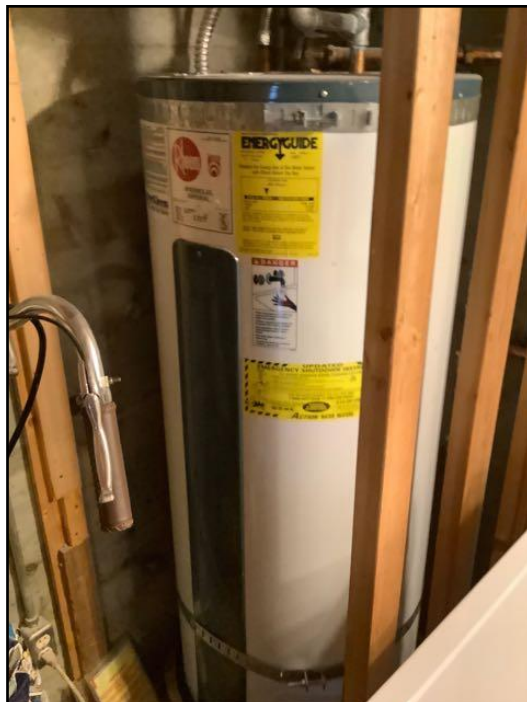
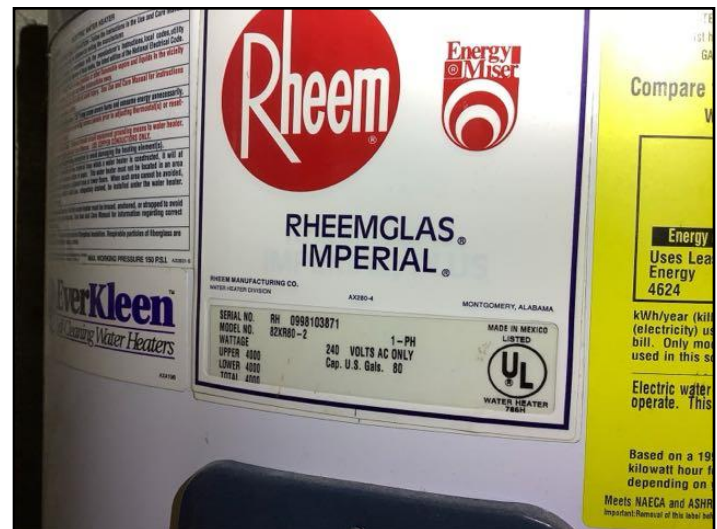
According to the serial number this water heater was manufactured in 1998.

Model number: 82XR80-2 Serial number: RH 0998103871

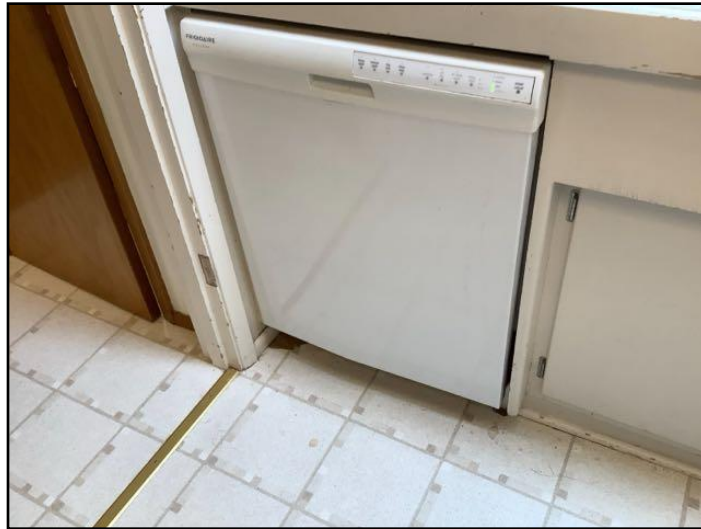
**54. Dishwasher**

The Dishwasher was tested and in working condition at the time of inspection.

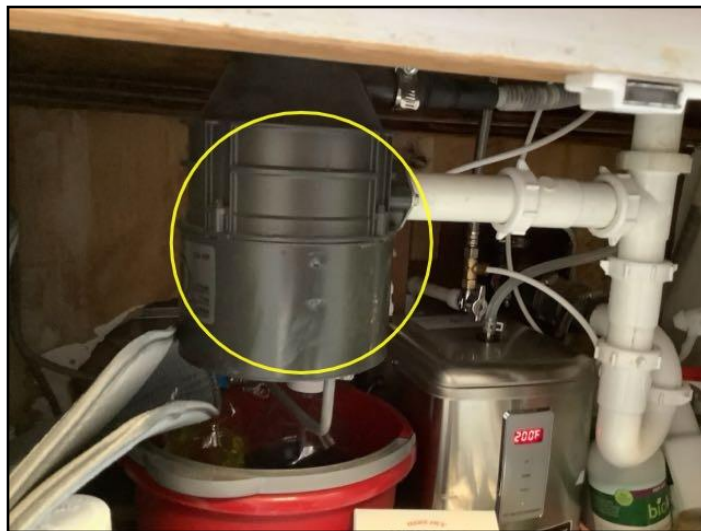
**55. Waste disposal**

This Waste disposal was tested and in working condition at the time of inspection.

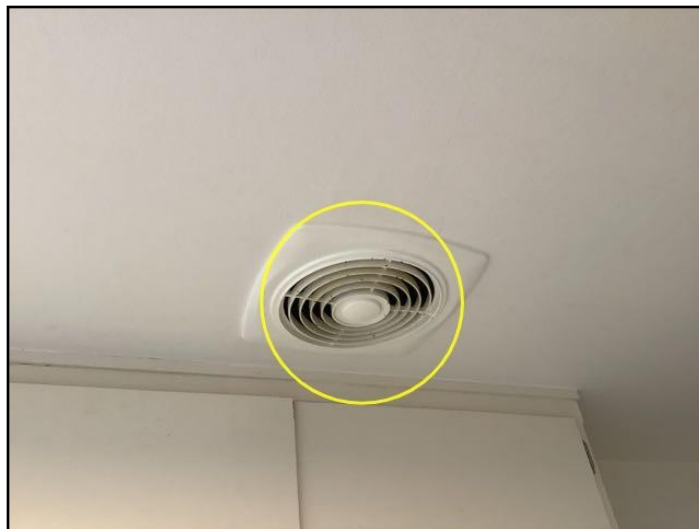
57. Ventilation fan

This fan located above the range was tested and working at the time of inspection.

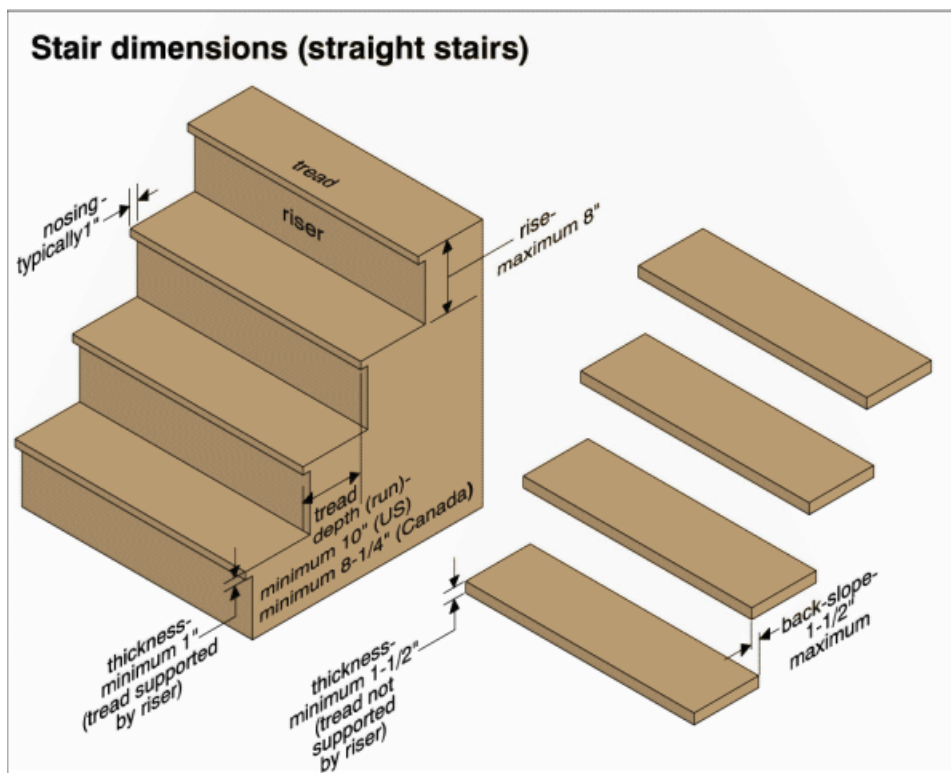
**24. Condition:** • [Rise excessive](#)

**Implication(s):** Trip or fall hazard

**Location:** Middle Basement Kitchen Staircase

**Task:** Improve

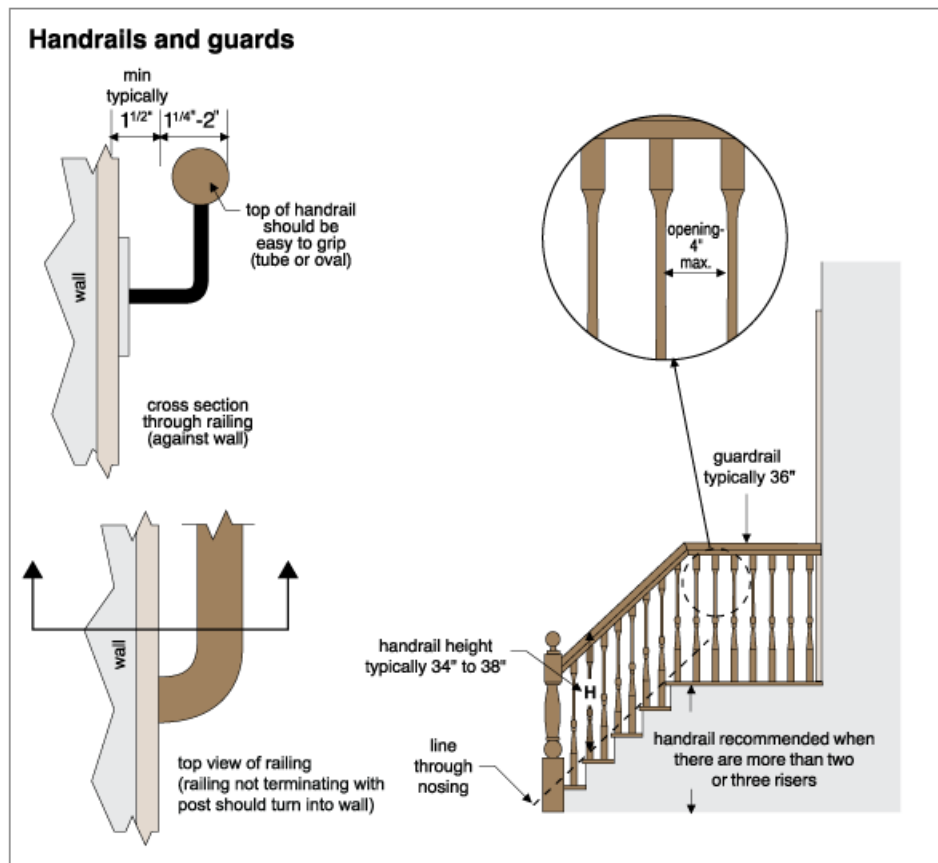
60. Too low

**25. Condition:** • [Too low](#)

**Implication(s):** Fall hazard

**Task:** Correct

**Time:** As soon as practical
